**Flood Control Project Maintenance
Levee Inspections**

2020 Channel Summary Report

Fairfield Suisun Sewer District

Laurel Creek

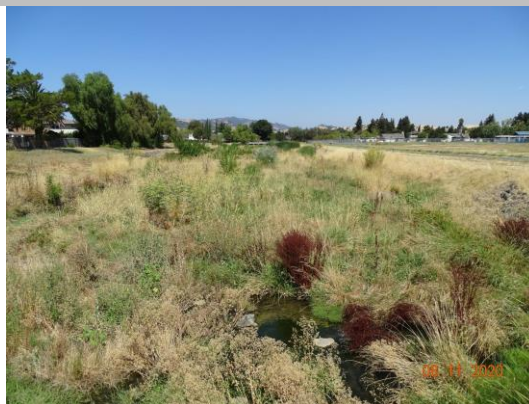
Photo 1 of 1 : CH_2020_NA0035_15_1_20200812_00044.jpg

Inspector Comments: Minimal scattered vegetation. The flow is not impeded.

View of the channel looking upstream. Summer 2020.

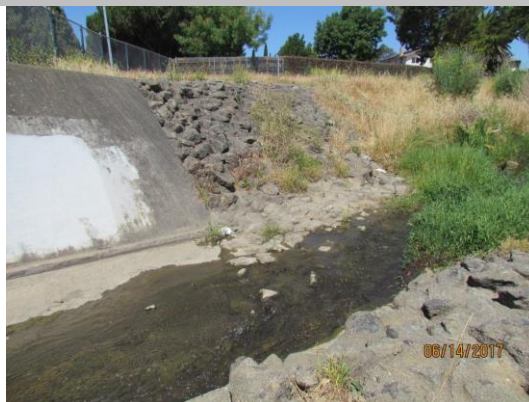
Photo 1 of 1 : CH_2020_NA0035_15_4_20200715_00002.jpg

View of revetment on right bank, looking upstream. Summer 2017.

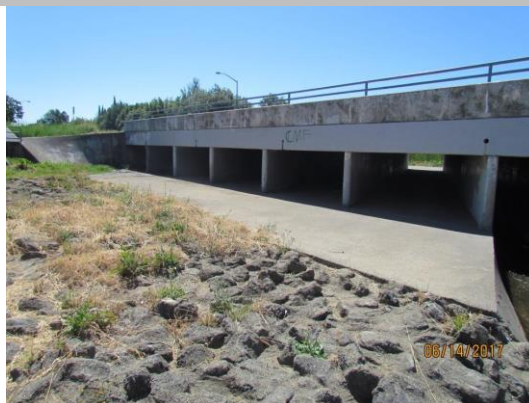
Photo 1 of 1 : CH_2020_NA0035_15_92_20200715_00026.jpg

Inspector Comments: Concrete surface appears to be in good condition with no visible deficiencies.

View of concrete surface, looking downstream at Cement Hill Road bridge. Summer 2017.

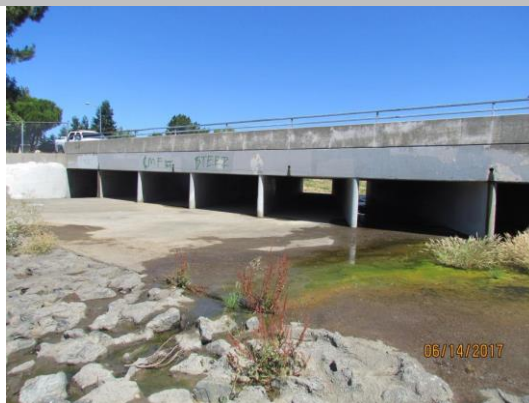
Photo 1 of 1 : CH_2020_NA0035_15_93_20200715_00027.jpg

Rating **	A	Issue No.	93	GPS Lat/Long
Issue Type +	Ma	Location *		38.279793 °
Category	Rivers, Channels & Designated Flood			-122.018267 °
Item	Concrete Surfaces			
DWR ID	DWR_NA0035_15_c_2017_93			
Action/Comments				
Inspector Comments: Concrete surface appears to be in good condition with no visible deficiencies. Recommend removing vegetation.

View of concrete surface looking upstream towards Cement Hill bridge. Summer 2017.

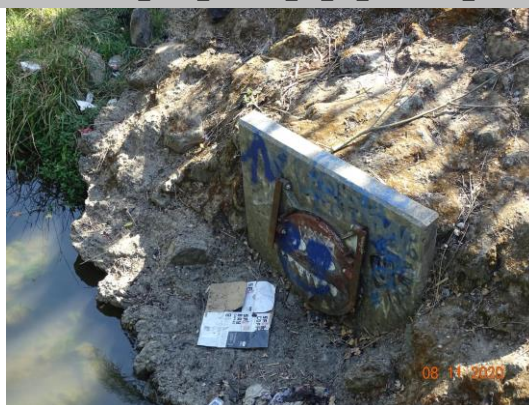
Photo 1 of 1 : CH_2020_NA0035_17_24_20200812_00026.jpg

Inspector Comments: Gate was recently repaired.

View of the flapgate located on the upstream side of Rockville Road. Summer 2020.

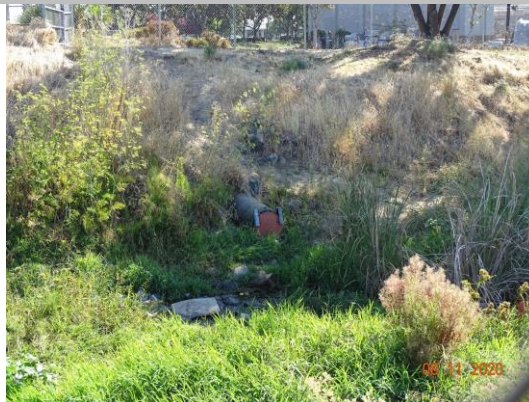
Photo 1 of 1 : CH_2020_NA0035_17_82_20200812_00030.jpg

Inspector Comments: Gates open and close easily with minimal leakage. Gates show no corrosion damage and have been maintained.

View of the gate on the downstream side of the channel from Auto Mall Pkwy. Summer 2020.
